## TD041 – MRC Systems FZE Testing

To determine the compatibility of Glass Reinforced Polyester (GRP) panels used in the construction of clean rooms to Hydrogen Peroxide Vapour (HPV) decontamination cycles.

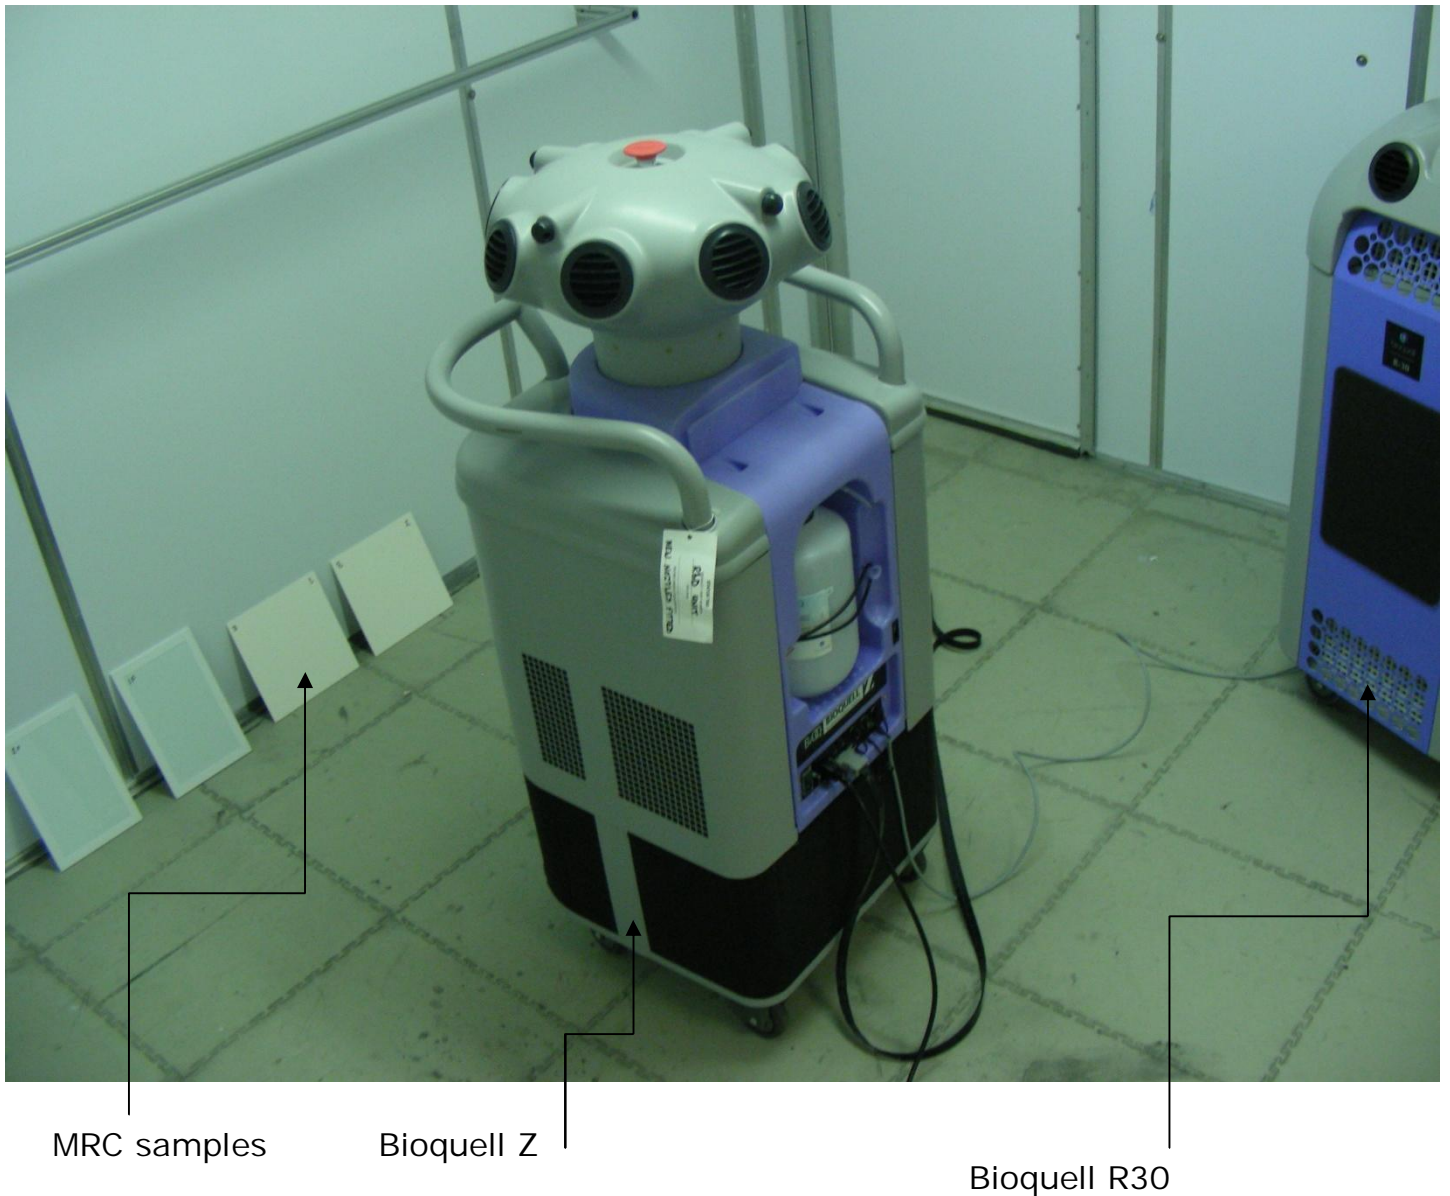
*Layout;*

The samples were leant against a wall of the test room, approximately 1.8 meters from the gassing nozzles of the BIOQUELL Z. An R30 Aeration unit was situated in the corner of the test room away from the gassing line to reduce aeration time.

A BIOQUELL Z (Serial No: 200811BZ00185) was placed in a room of the following dimensions: 3.1m x 2.5m x 3.5m which has the total volume of 27m<sup>3</sup>

An R30 Aeration unit (Serial No: 201008R30000) was connected to the BIOQUELL Z to reduce the Aeration time.

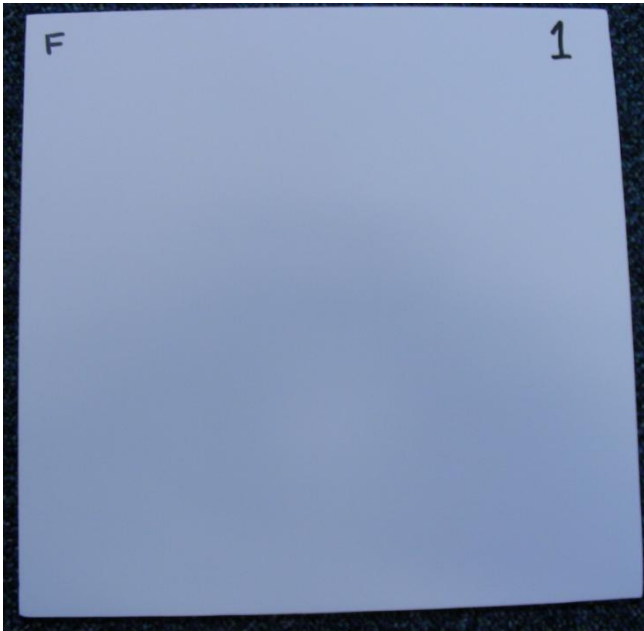
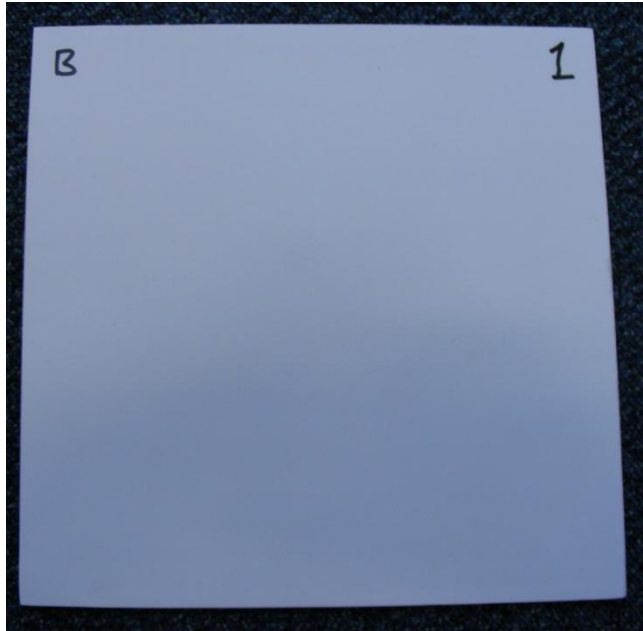
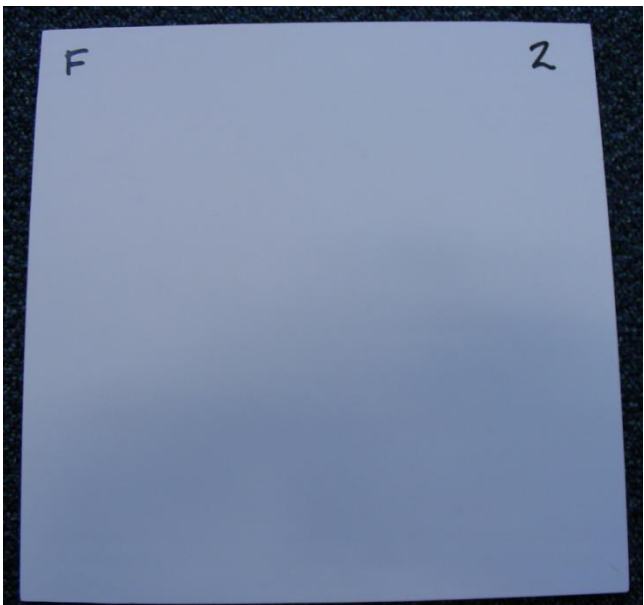
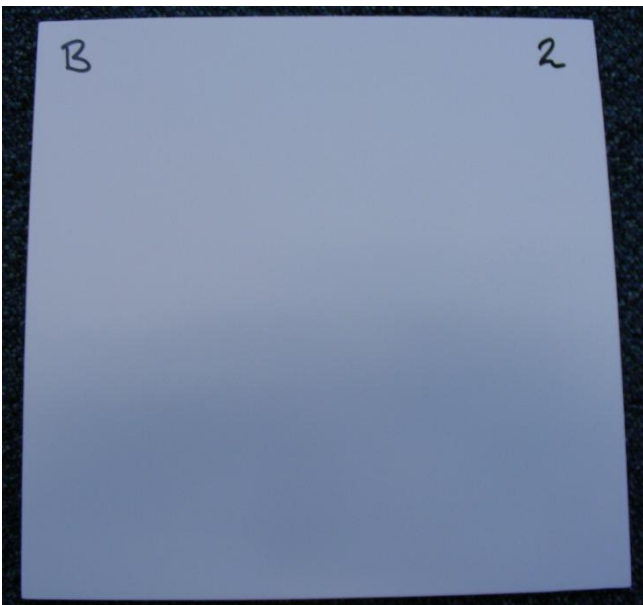
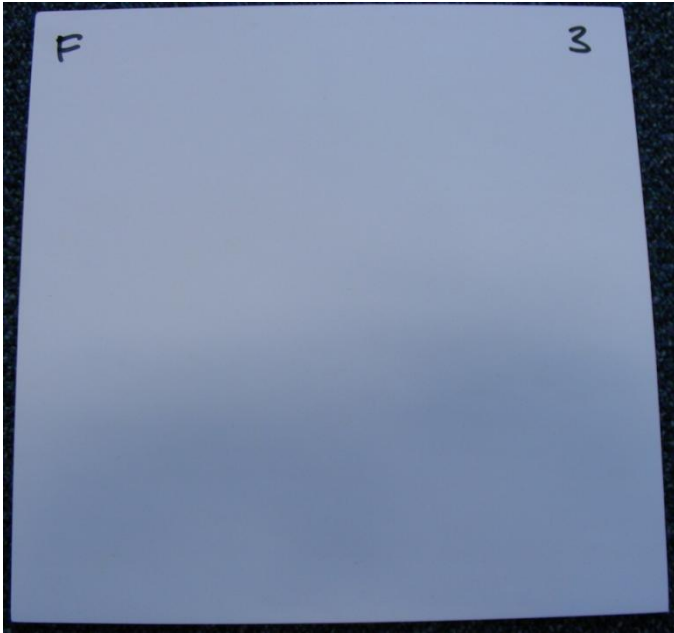
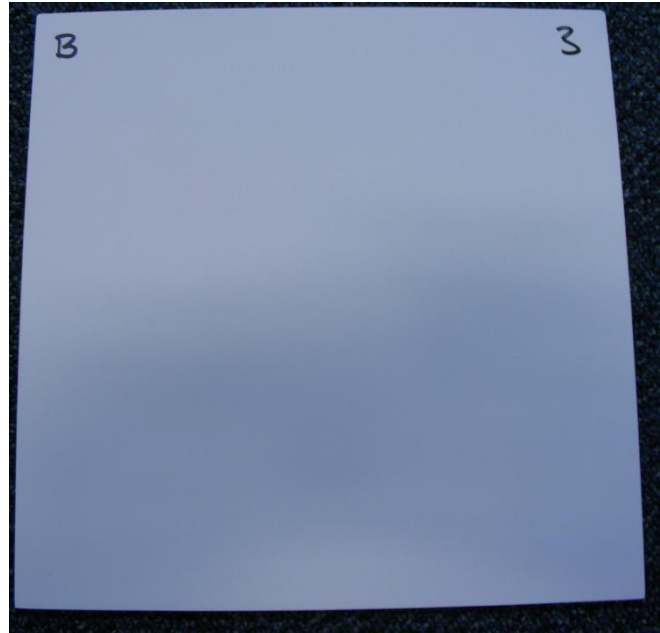
Start Photos

The samples were photographed pre-test and post test (40 cycles). The three photographs are shown for each sample. Note sample 1 was left outside the room as a control to compare against at the end of the test. Each sample was photographed front (F) and back (B).
